# Electrical phenomena associated with vegetation in contact with medium voltage conductors: summary of field experiments

**Keywords:** vegetation contact, incipient fault, high-impedance fault, vegetation management, wildfire mitigation

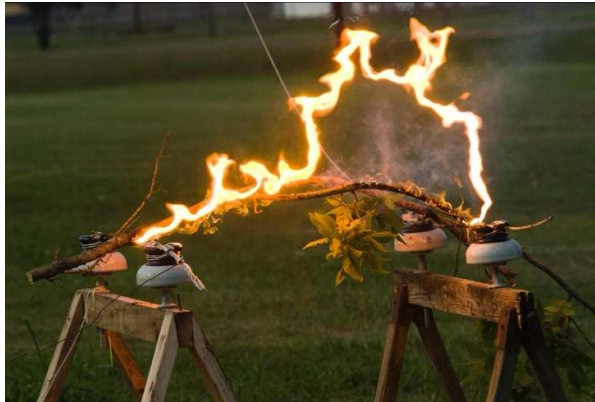
In the 2006 experiments, researchers used sawhorses with attached insulators to construct two parallel conductors, and laid branches of multiple types of trees across the conductors at varying lengths. The energized phase conductor was protected by a 2-ampere Type-T fuse, and the neutral conductor was grounded through a 500-ohm resistor board to limit fault current at the site and subsequent voltage drop seen by active customers on the circuit. The test setup can be seen in Figure 1, which shows an arc drawn between the two conductors following a flashover event.

Figure 1: Test setup in 2006 experiments, during flashover event.

Researchers observed that as the branch was energized charring and scintillation began immediately at both ends of the branch where the vegetation contacted the conductor. The charred path began to extend from both ends of the branch toward the centre. Eventually the two charred paths came close enough to each other to produce a high-current flashover. Due to the 500-ohm intentional resistance in the path, the fault current was limited to 14.4A and given the intermittent nature of the arcing the 2A fuse did not immediately clear. Instead, the fault current produced multiple, dramatic “Jacob’s ladder” arcs, photos of which have been widely circulated online. The timeline from energization to flashover varied slightly depending on separation distance but generally lasted several minutes. While there was no formal measurement device at the fault point, a fluke meter hung on the conductor registered less than 0.3A during the duration of the tests before flashover.

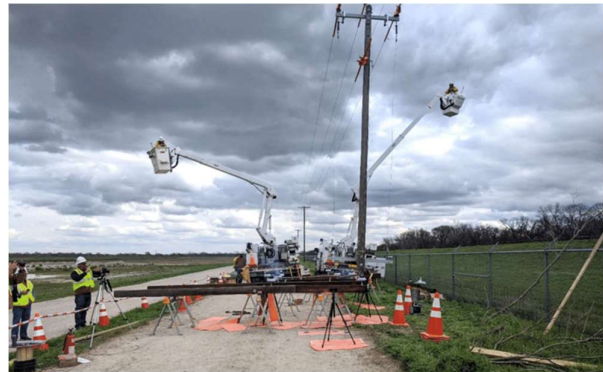
phase-to-phase and phase-to-neutral connections, and energized conductors were protected with 100A fuses. In contrast to the Texas A&M Facility, the Oncor test facility had a substantially higher available fault current of approximately 4,000 amperes (line-to-neutral). A wide angle view of the test facility can be seen in Figure 2.

Figure 2: Oncor test facility (2020 tests)

To address limitations of the 2006 experiments, researchers at Texas A&M University partnered with John Goodfellow of BioCompliance Consulting and Oncor Electric Delivery to perform a series of experiments on an active distribution circuit in the Dallas, Texas area [3]. With input from researchers, Oncor constructed a test setup served by an active distribution circuit at a water treatment plant. The test setup was served by a three-phase section of line with a nominal circuit voltage of 7.8/13.5kV. The test setup allowed for both

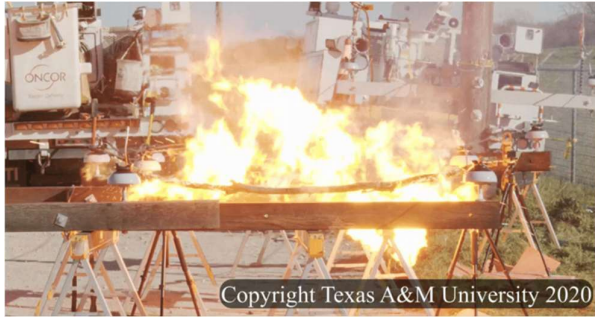
Unlike previous events where impedance limiting resulted in dramatic power arcs, the high available fault current combined with relatively small 100 ampere fuses resulted in immediate fuse operation and clearing of the high current fault. Figure 3 shows the end of one such test as the high-current arc is extinguished.

Figure 3: Extinguishing of high-current arc from 2020 tests.

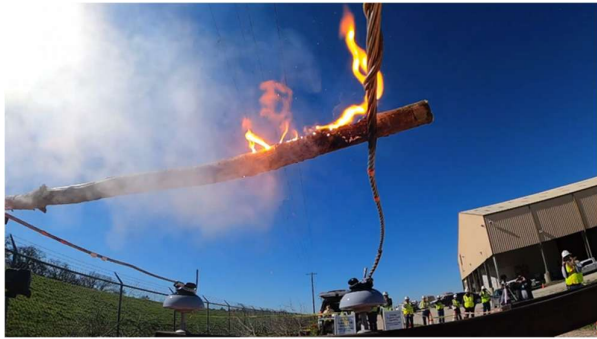
The high-speed video shed new light on the behaviour of arcing, particularly in the early stages of fault formation. Figure 4 and Figure 5 show images captured from high-speed video during one test.

Figure 4: Arcing visible at sub-ampere current levels

One particularly important finding from the video recordings combined with electrical measurements taken at the fault point is that substantial arcing activity can exist even at relatively low current levels. In particular, the image in Figure 4, which is not cherry-picked, shows arcing occurring below the 500mA limit that is often cited as an important level for reducing the probability of ignition. Figure 4 and Figure 5, along with images obtained from other tests, suggest that branches in a similar configuration could represent a competent ignition mechanism given an appropriate fuel load.

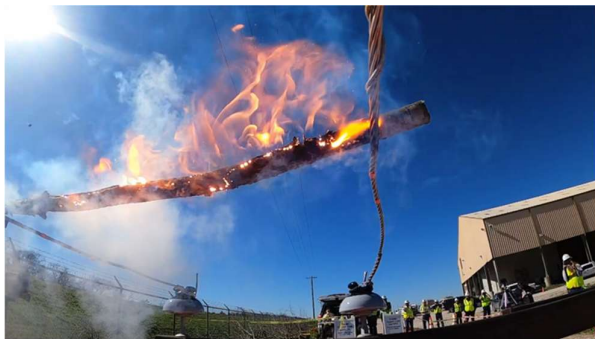
Figure 5: Flames and arcing just before flashover
